## **To the New Owner of this Roll Top Secretary Desk**

Refurbished by David A Ramsey in March of 2019.

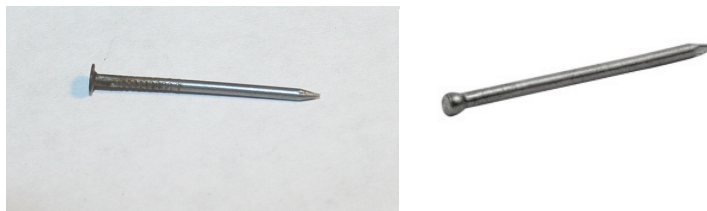
- The nails used to secure the back and top of cubby hole assembly were not like current finish nails, but I have not been able to find any information to definitively date them.

Note the thin head instead of widened head of current finish nails showed at right

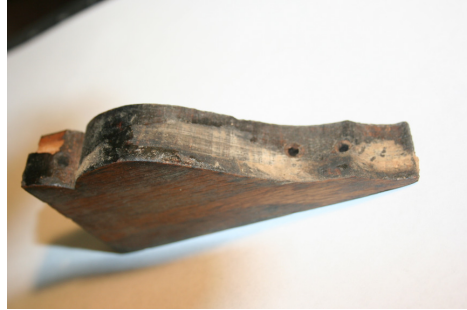
- I did note the bottom braces between the legs had heavy saw marks on the bottom where to decorative curves were cut. Also the decorative piece between the legs and the side panels had similar saw marks. I don't think this fact says anything about the date of manufacture but it could mean that the desk was hand made. Not made in a factory.

**Showing saw marks on the curved surfaces**

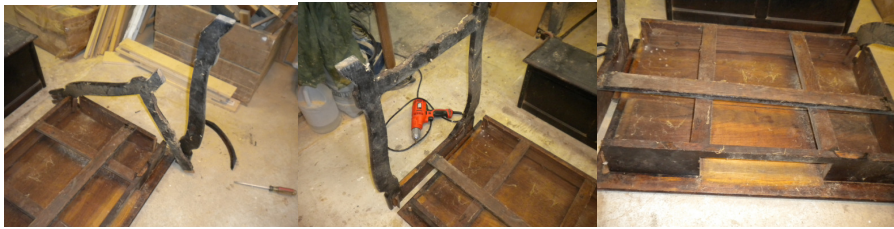
**Desk top assembly showing legs coming apart**

- Obviously the condition of the piece structurally and the poorly applied black finish required the desk be completely disassembled and the finish stripped for reassembly and refinishing. Disassembly was easy since all the glue joints were loose and easily pulled apart by hand or with a few soft whacks with a hammer.

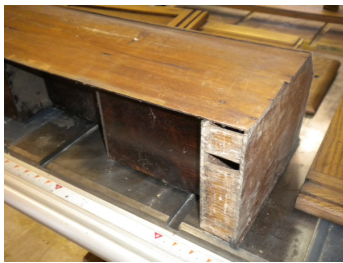
**Damage to side bottom of cubby hole assembly shown from bottom**

- The finish was difficult to remove, requiring multiple applications of paint stripper and scraping between applications. The most difficult part was removing the finish from the cubby hole assembly. It required many applications of paint remover and finish remover. I removed the back and the top panels to get access to the inside surfaces. The top and back panels were damaged and cracked so I replaced them with plywood. I also had to replace the side bottom panels that are shown in picture damaged

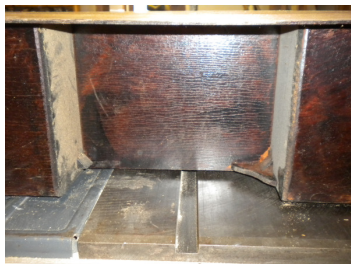
**Cubby hole assembly shown from bottom. Note black stain**

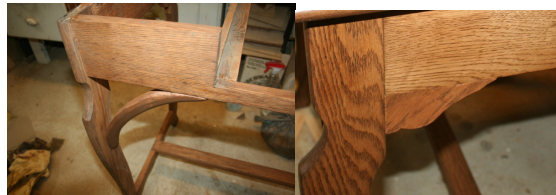
**New part shown at left, new decorative piece on right**

- I made one new leg brace and four decorative side pieces. One brace was missing and three decorative pieces were missing and the other was damaged. The damaged one is shown above.

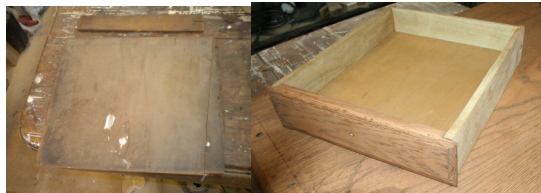
**Damaged drawer bottom and back, drawer with new parts added**

- The large middle drawer was coming apart and bottom and back were damaged. I replaced the damaged bottom oak faced plywood and the back with solid poplar.

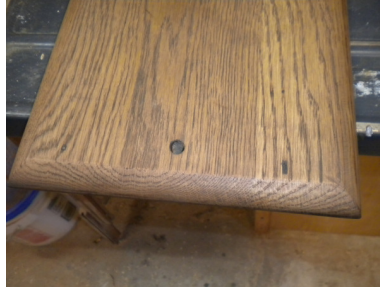
**Top of Tambour Door Assembly showing nail holes and  
dowel hole in middle, dowel was missing**

- There are some nail holes that I left as part of the history of the desk. Nails were added to some joints in what appears to have been an attempt to repair the loose joints. My intent was to keep the desk as close to its original design as possible, but it was impractical to try to leave the finish as found, which was not the original finish anyway. The desk was not viable with all original parts since many were missing or damaged and the glue joints were not secure.
