## **To the New Owner of this Roll Top Secretary Desk**

Refurbished by David A Ramsey in March of 2019.

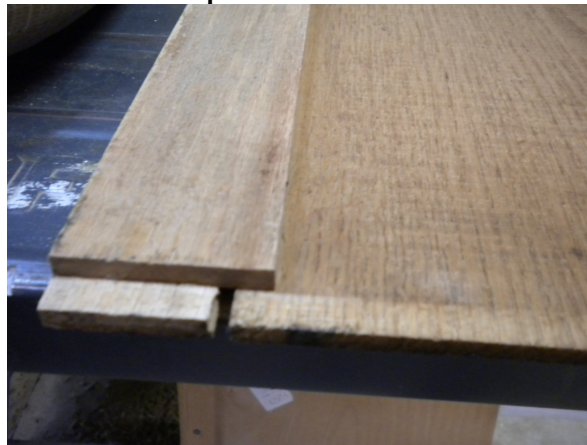
**This is back panel 1/4 inch thick solid oak**

**Back panel showing vertical saw marks**

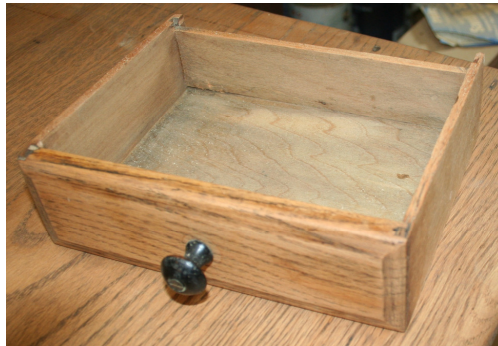
- The mixture of woods such as in the small drawer sides of Poplar and oak might mean the desk was made in a cabinet or furniture shop rather than a factory.

**Drawer front and right side are oak, the left side, back and bottom are what appears to be poplar**

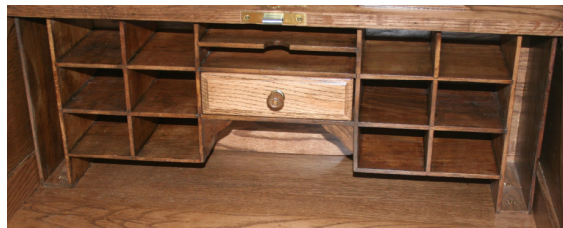
- The cubby hole assembly also has mixed wood.

**All panels are made of 1/4 solid poplar except two panels at bottom left are solid oak**
